## Confidential Inspection Report

123 Any St  
Wasilla, AK 99654

INSPECTED ON:  
Monday, August 16, 2021

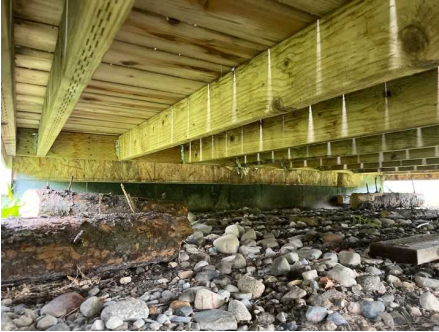
**1:** The deck was attached to the home by a ledger with only nails. [...more](#)

**H&S** The deck was attached to the home by a ledger with only nails. Generally-accepted modern standards specify the use of lag screws to fasten ledgers.

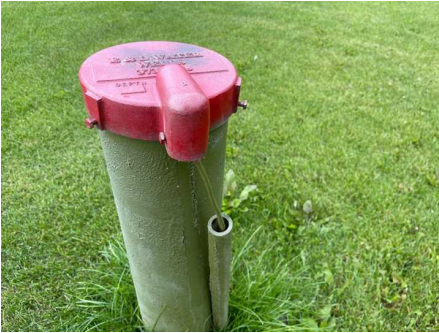
**2:** The conduit protecting the electrical wires for the well-head was damaged. [...more](#)

**H&S** The conduit protecting the electrical wires for the well-head was damaged.  
The Inspector recommends repair to prevent damage to the electrical components.

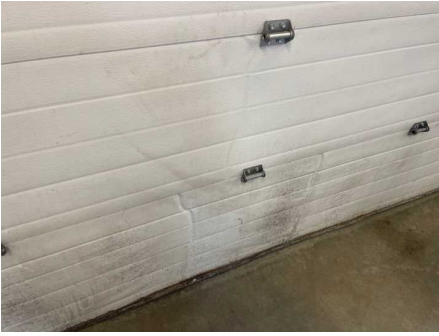
**MTN 8:** A garage vehicle door panel had minor damage visible. [...more](#)

**MTN** A garage vehicle door panel had minor damage visible.

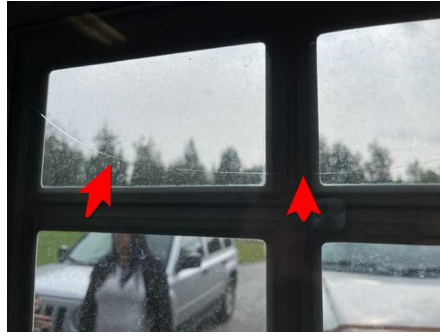
Cracked windows big door

**MTN 9:** One of the small windows in the large garage door had a crack. [...more](#)

**MTN** One of the small windows in the large garage door had a crack. The inspector recommends repair by a qualified professional.

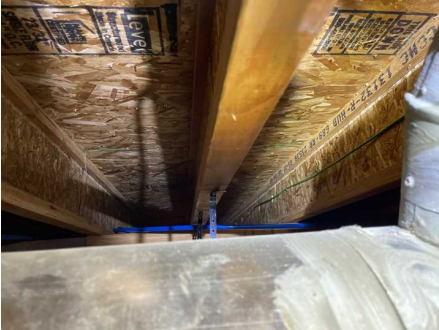
**4:** In the crawlspace, blocking was missing between floor joists on a load-bearing wall. [...more](#)

**PRM** In the crawlspace, blocking was missing between floor joists on a load-bearing wall. Blocking is lengths of wood between joists designed to keep the framing from shifting. The inspector recommends evaluation and installation by a qualified professional.

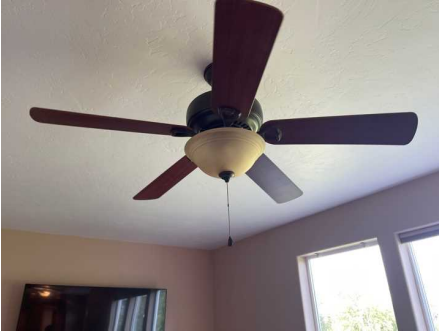
Living room

**MTN 10:** A light fixture in the living room did not respond to the switch. [...more](#)

**MTN** A light fixture in the living room did not respond to the switch. If after the bulb is replaced this light still fails to respond, there may be a problem with the switch, wiring or light fixture. Evaluation and any necessary repairs should be performed by a qualified electrical contractor.

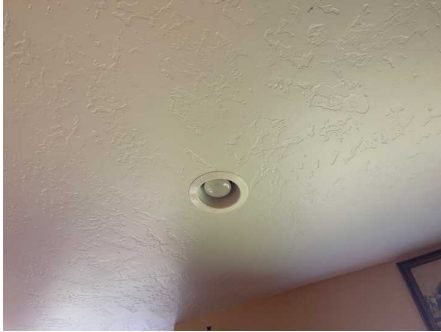
**MTN 11:** A light fixture in the kitchen did not respond to the switch. [...more](#)

**MTN** A light fixture in the kitchen did not respond to the switch.

If after the bulb is replaced this light still fails to respond, there may be a problem with the switch, wiring or light fixture. Evaluation and any necessary repairs should be performed by a qualified electrical contractor.

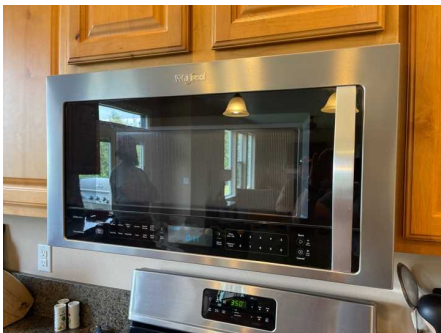
**MTN 12:** Range hood lights would not turn on. [...more](#)

**MTN** Range hood lights would not turn on.

If after replacing the bulb the light fixture still does not respond, there may be a problem with the switch, wiring or light fixture and the Inspector recommends service by a qualified contractor.

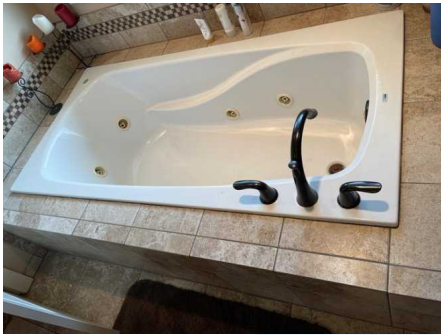
**5:** Jets in the tub in the master bathroom did not respond to the controls. [...more](#)

**PRM** Jets in the tub in the master bathroom did not respond to the controls. The Inspector recommends repair by a qualified plumber contractor.

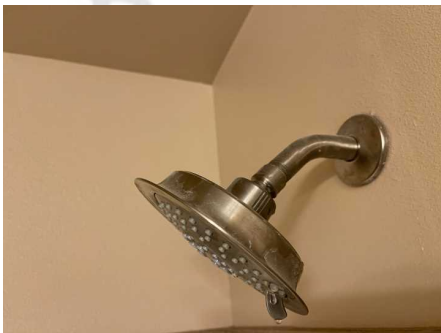
Upstairs bathroom

**MTN 14:** Showerhead connections leaked in the upstairs bathrooms. [...more](#)

**MTN** Showerhead connections leaked in the upstairs bathrooms. The inspector recommends service by a qualified plumbing contractor.

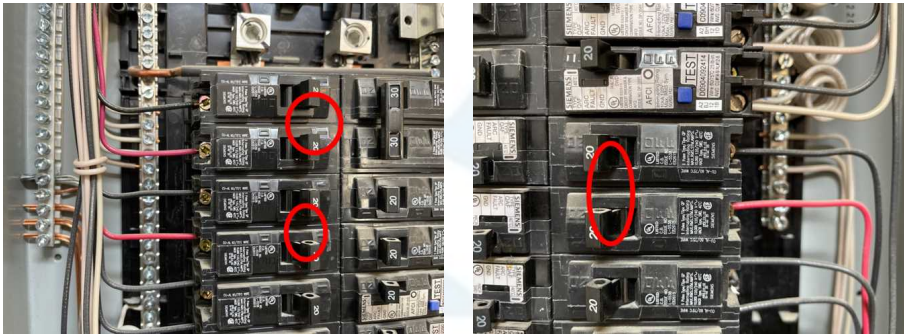
**3:** There were no handle ties on breakers sharing a neutral in the electrical panel. [...more](#)

**H&S** There were no handle ties on breakers sharing a neutral in the electrical panel. Handle ties are a small piece that connects two breakers so that if one of them is tripped, the other one trips as well. This helps to protect home occupants from overcurrent or electrical shorts. The handle tie can be installed by a qualified electrical contractor.

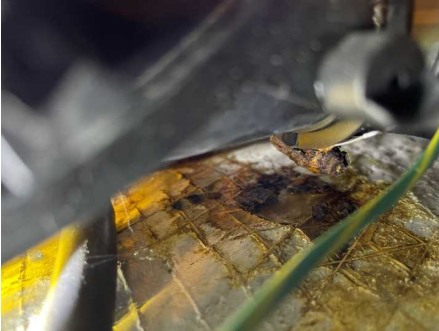
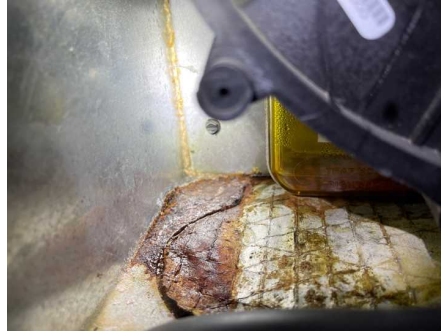
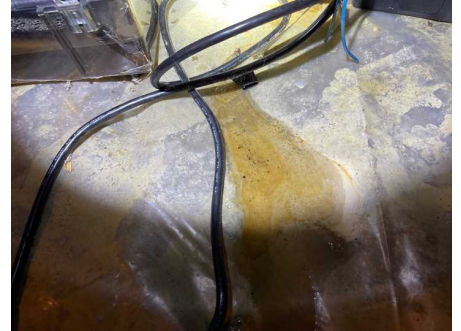
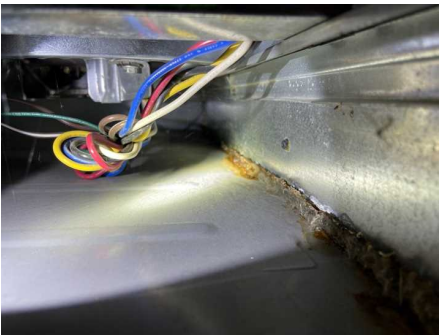
**6:** The furnace condensate tube was broken and fluid was leaking onto the floor. [...more](#)

**PRM** The furnace condensate tube was broken and fluid was leaking onto the floor. High-efficiency furnace exhaust produces condensate fluid which must be properly discharged. The Inspector recommends correction by a qualified heating, ventilation and air-conditioning (HVAC) contractor.
