## Confidential Inspection Report

123 Any St  
Wasilla, AK 99654

INSPECTED ON:  
Monday, August 16, 2021

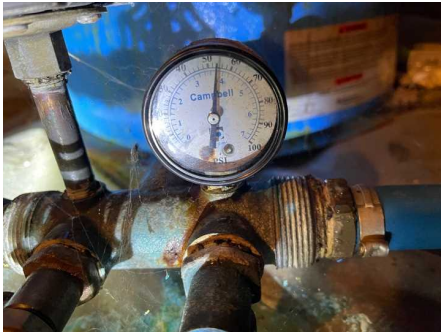
### Water Pressure

Water pressure measured 55 pounds per square inch (psi) at the time of the inspection. Acceptable water pressure is between 40 and 90 psi.

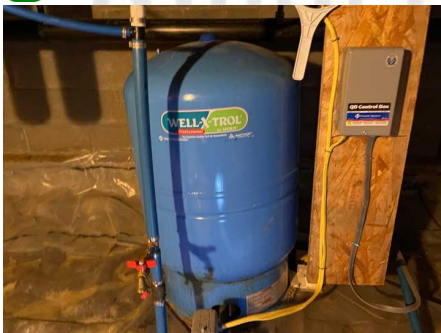
### Tanks

The home had a pressure tank for adding pressure to the home water supply.
